Manhole Inspection Summary

Manhole # S23GG2006MH

Location Address: **1010 Bellemore Road**

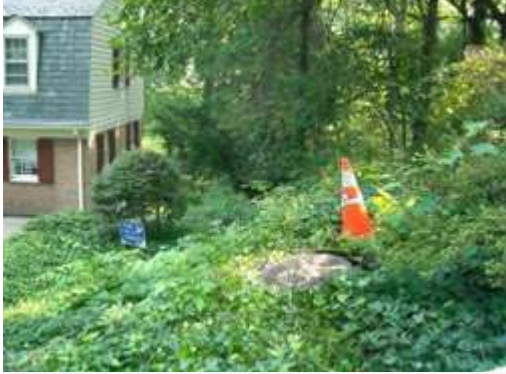
Location View

Comments **IVY/WOODED AREA 8 FEET BEHIND STORM DRAIN INLET**

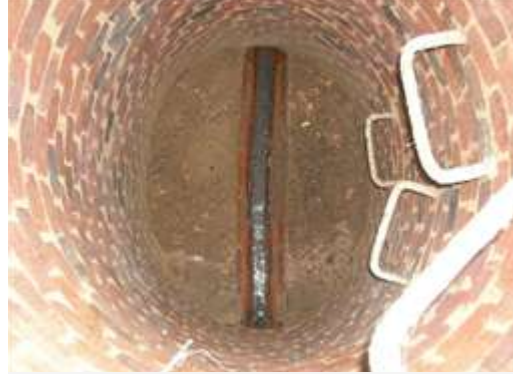
Top View

Bench ☒ Exists Material: **Brick** ☐ Parged ☒ **Debris** (not Condition related)

Surcharge ☒ **Evidence Of Surcharge** Depth: **1** (ft.) ☐ Active Surcharge Present

Evidence of surcharge - Bench debris.

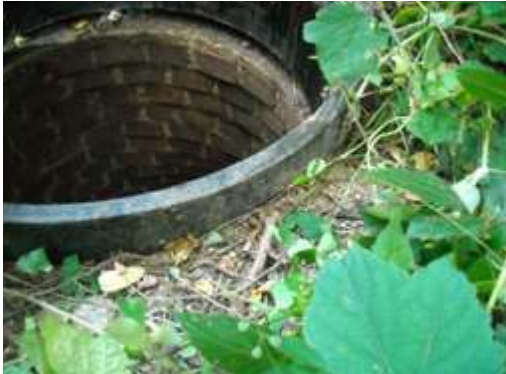
Defect

Cover Shape: **Circular** Diameter: **24** (in.) Length: (in.) Dist A/B Grade: **1.5** (in.)

Frame Offset: **0** (in.) Condition: ☒ Sound ☐ Cracked ☐ Leaks

Infiltration: ☐ None ☒ **Joint** ☐ Cracks ☐ Mortar ☐ Roots ☐ Wall

Above grade. Frame offset. Corbel infiltration.

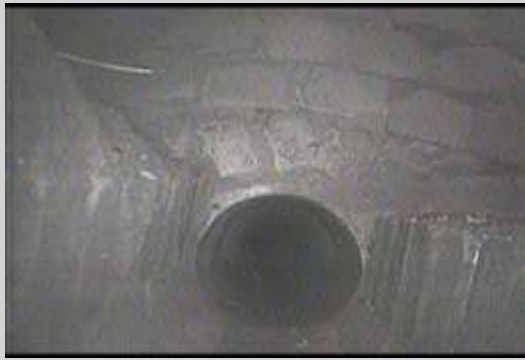
8 in. Circular Gravity Sewer Pipe Out @ 12 O'Clock

Rod and Bar (Angled)

Pipe Material: **Clay** ☐ Pipe Lined

Invert Depth: **8.25** (ft.) Flow Characteristics: **Slow**

Deposits: ☒ None ☐ Mud ☐ Sludge ☐ Debris ☐ Grease

Infiltration: **None** Pipe Seal Cond: **Unknown**

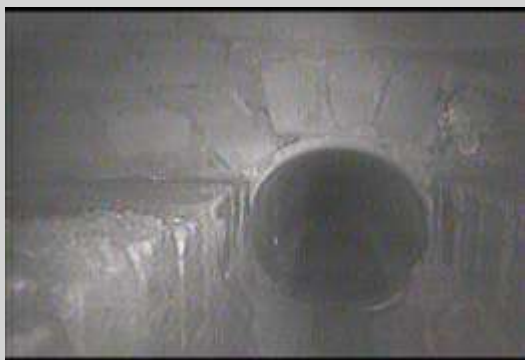
8 in. Circular Gravity Sewer Pipe In @ 6 O'Clock

Rod and Bar (Angled)

Pipe Material: **Clay** ☐ Pipe Lined

Invert Depth: **7.73** (ft.) Flow Characteristics: **Slow**

Deposits: ☒ None ☐ Mud ☐ Sludge ☐ Debris ☐ Grease

Infiltration: **None** Pipe Seal Cond: **Unknown**
